## Fire Testing of Exterior Wall Systems

*Investigative testing conducted in accordance with the test methodology described in CSFM 12-7A-1, Materials and construction methods for exterior wildfire exposure – Exterior wall siding and sheathing*

**Nominal 1x6 T&G Nickel Gap/Reverse Thermo Ambara (Ayous/Obeche)  
7/16” OSB Sheathing**

**WFCi Report #25068**

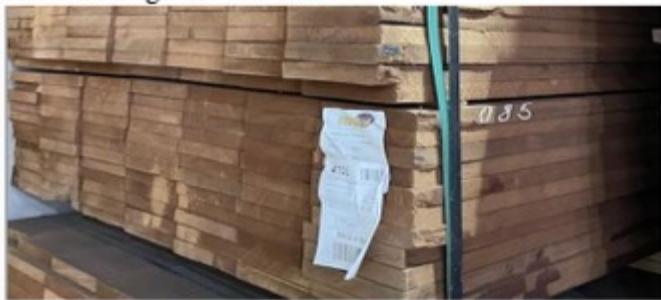
Photo 1 Rough Sawn Stock

The rough sawn boards were received from Nova USA Wood Products LLC and measured approximately 1 x 6 inches before being milled.

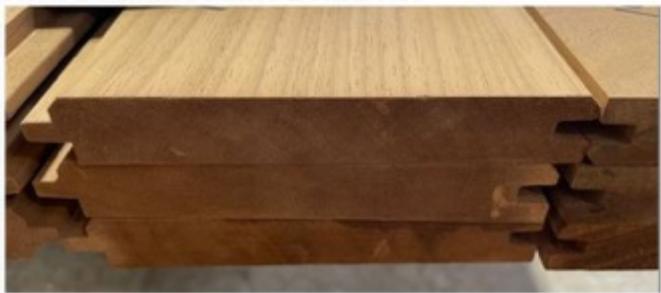
Photo 2 Finished Milled Deck Board

The rough sawn boards were fed thru a planer to mill to the finished profile.

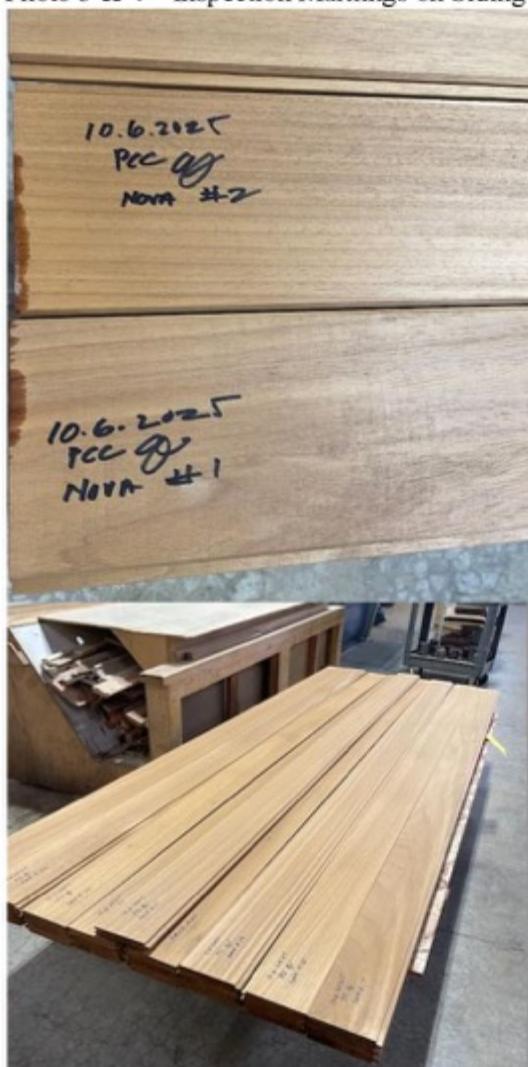
Photo 3 & 4—Inspection Markings on Siding

10.6.2025 PCC GT(cursive initials of inspector) NOVA #1 thru #25
