Fire Testing of Exterior Wall Systems

Investigative testing conducted in accordance with the test methodology described in CSFM 12-7A-1, Materials and construction methods for exterior wildfire exposure – Exterior wall siding and sheathing

**Nominal 1x6 T&G Nickel Gap/Reverse Thermo Ambara (AyouS/Obeche)
7/16" OSB Sheathing**

WFCi Report #25068r2

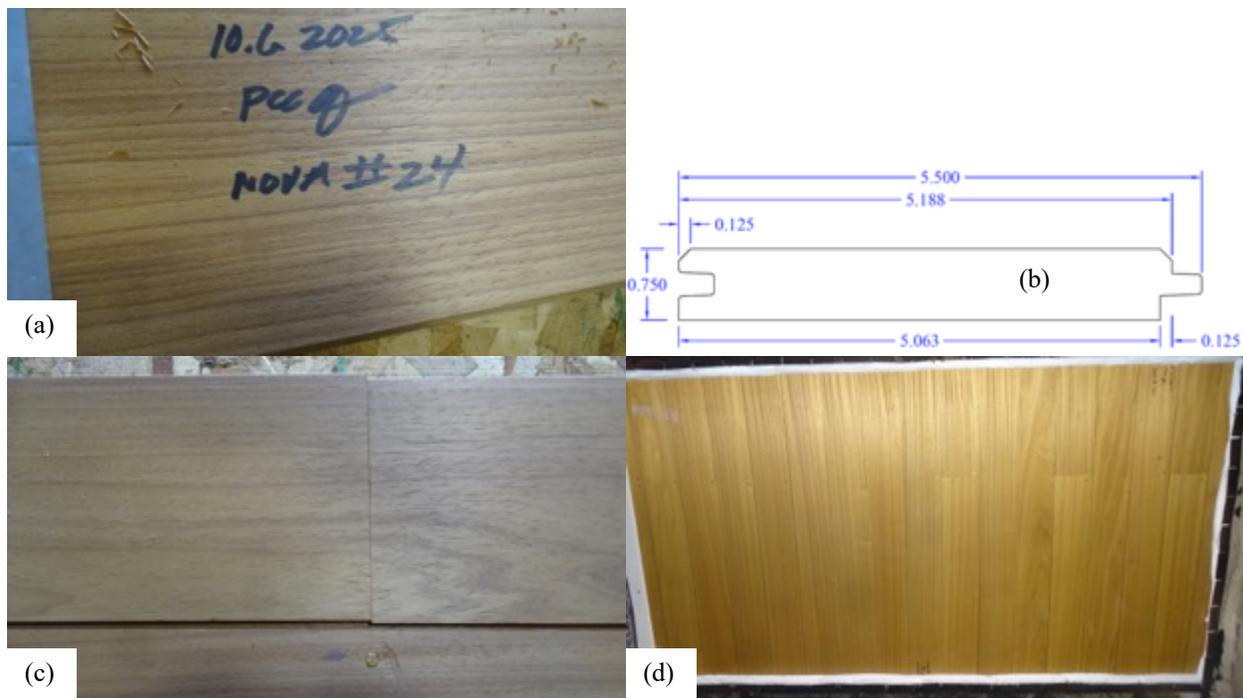
For testing purposes, a 4'×8' representation of an exterior wall assembly used for the CSFM 12-7A-1 test. Three walls were built (Figure 2), which consisted of a nominal 2×4 wood frame with studs spaced at 16" on center. A layer of 7/16" OSB sheathing was nailed to the studs with 8d nails at 6" on edge and 12" in the field spacing with an 1/8" vertical gap was placed along one of the interior studs. The outer siding consisted of a nominal 1×6 T&G nickel gap/reverse siding of thermo ambara wood (ayous/obeche), fastened horizontally to the sheathing with 6d ring-shank nails with tight vertical joints, a single nail per stud just below the horizontal joint.

Figure 2. Wall system showing (a) identification, (b) profile, (c) joint, and (d) complete assembly.

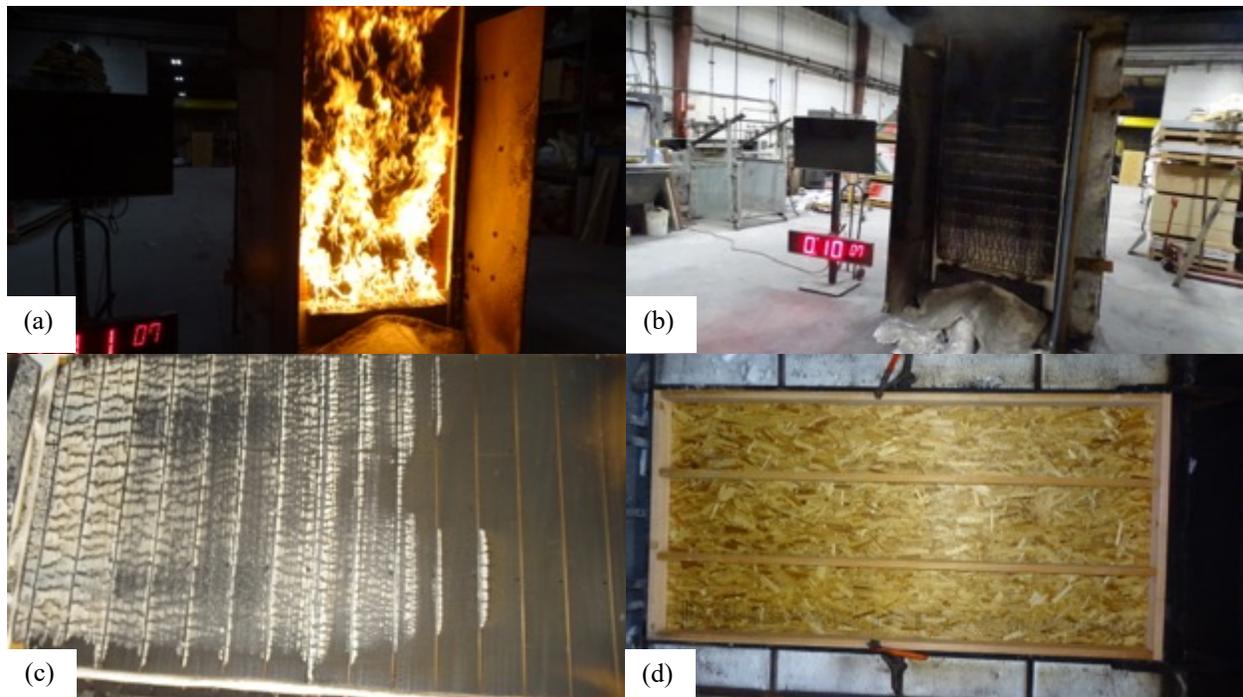
Test Time (mm:ss)	Event	Test Time (mm:ss)	Event
00:00	Start test – 150 kW burner on	00:45	Darkening of boards with attached flames
01:30	Flames reached to top of wall	05:00	No significant change
10:00	Burner off – flames self-extinguished	10:30	IR 59°C (maximum on backside)
12:00	IR 62°C	15:45	Minimal glowing on face
16:15	IR 63°C	18:50	IR 65°C
23:45	IR 73°C	33:25	IR 80°C
42:25	IR 74°C	45:00	IR 70°C
47:30	IR 65°C	50:30	IR 60°C – no signs of combustion on sample – Passed

Figure 2. Test 1 showing (a) flames up face, (b) burner off, and (c-d) after test.

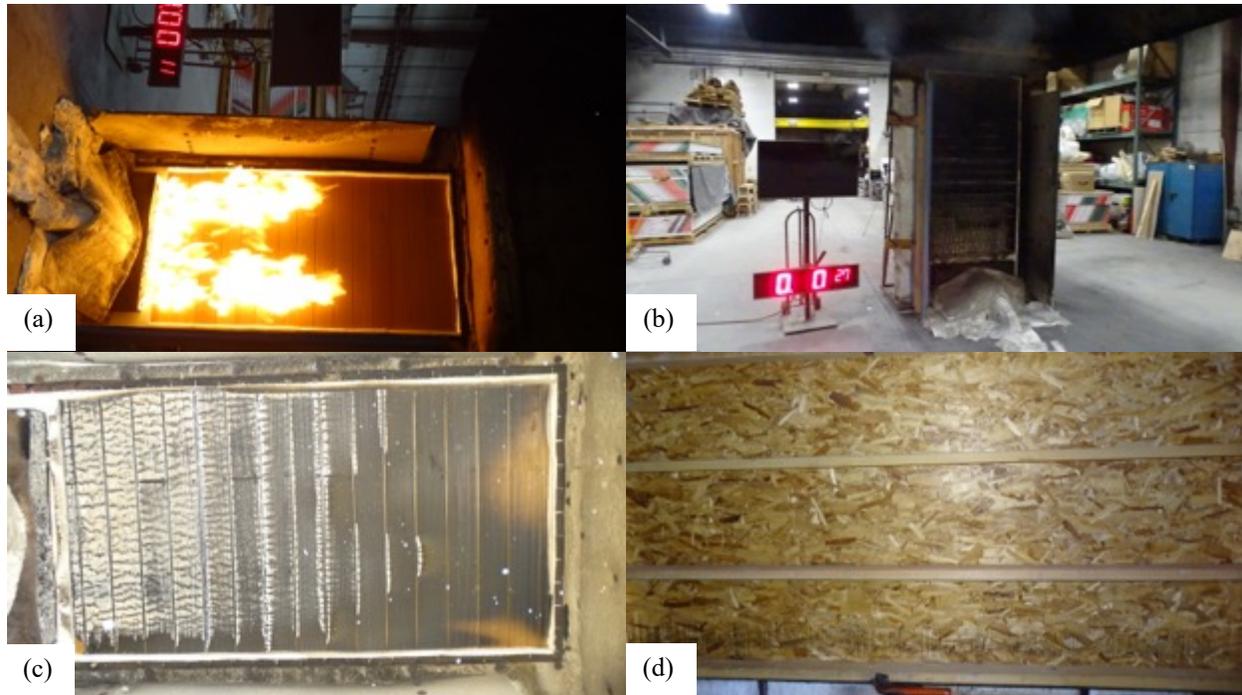
Test Time (mm:ss)	Event	Test Time (mm:ss)	Event
00:00	Start test – 150 kW burner on	00:30	Boards starting to darken
00:45	Attached flames	01:20	Flames to top of wall
10:00	Burner off	11:30	IR 60°C (maximum on backside)
14:00	IR 65°C	31:00	IR 84°C
45:00	IR 87°C	46:00	IR 89°C
47:15	IR 90°C	56:30	IR 93°C
1:00:00	IR 85°C	1:05:00	IR 100°C
1:10:00	IR 103°C – terminate test – no glowing or darkening on backside of wall – Passed

Figure 3. Test 2 showing (a) burner on, (b) burner off, and (c-d) after test.

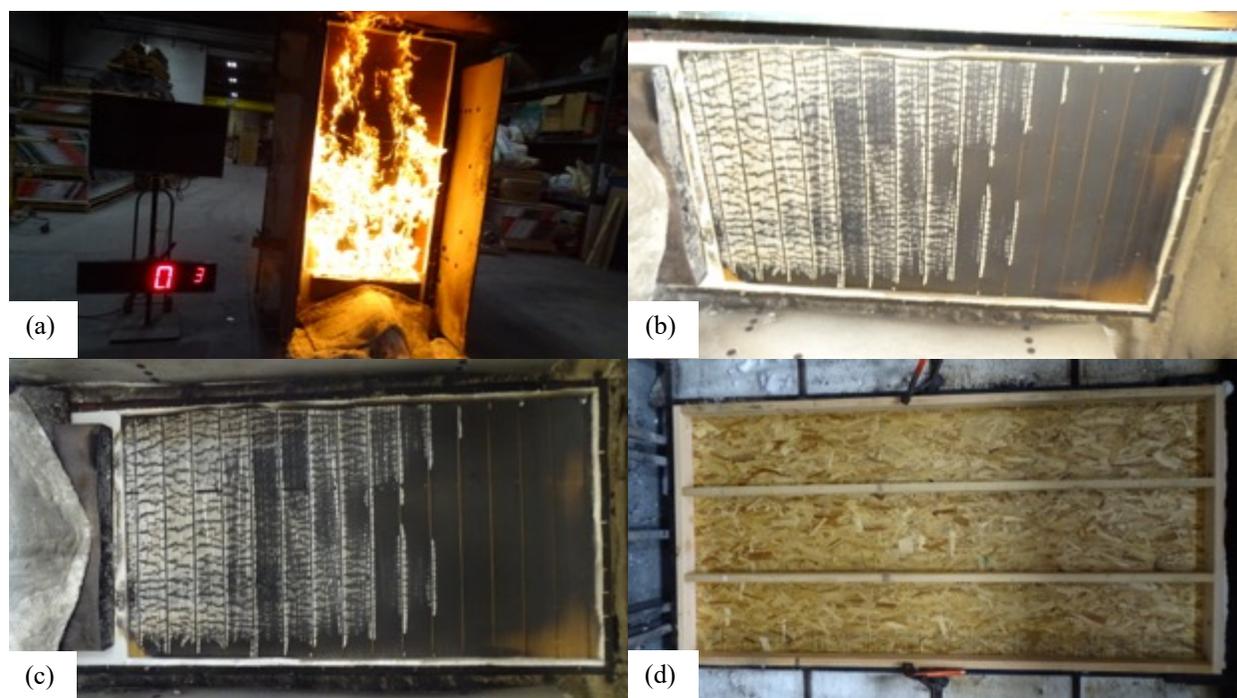
Test Time (mm:ss)	Event	Test Time (mm:ss)	Event
00:00	Start test – 150 kW burner on	00:45	Attached flames on wall
01:30	Flames at top of wall	05:00	Whole face is darkened
10:00	Burner off – IR 55°C (maximum on backside)	13:45	IR 62°C
21:00	IR 63°C	29:30	IR 65°C
37:25	IR 61°C	45:20	IR 52°C
50:00	IR 48°C – terminate test – no signs of combustion – Passed

Figure 4. Test 3 showing (a) burner on, (b) burner off, and (c-d) after test.

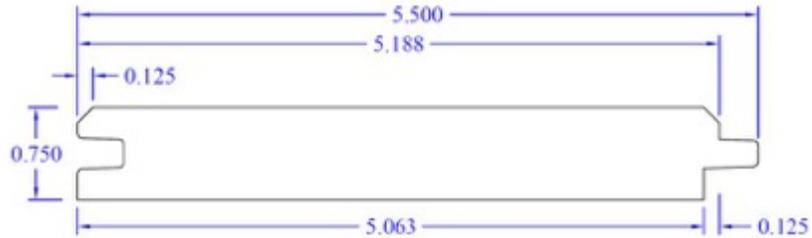
Twenty-five (25) milled siding lengths 3/4 x 5-1/2 tongue and groove.
See detail below.

Boards #1-25 measured 3/4 x 5-1/2 inches.

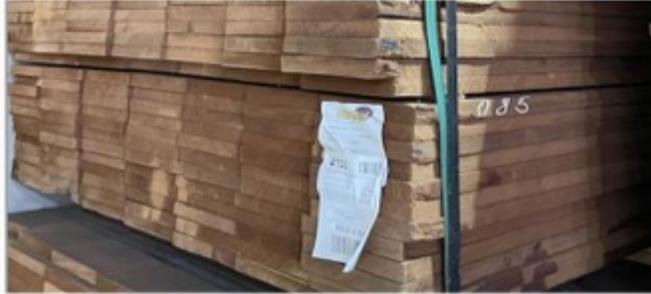
Photo 1 Rough Sawn Stock

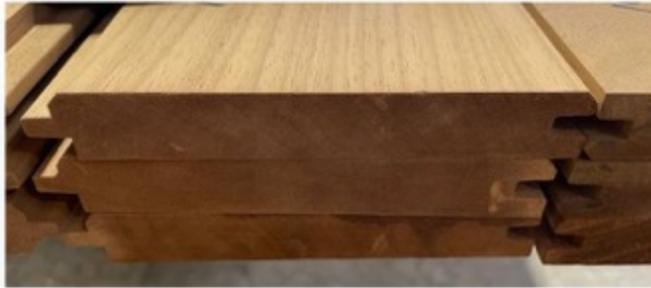
Photo 2 Finished Milled Deck Board

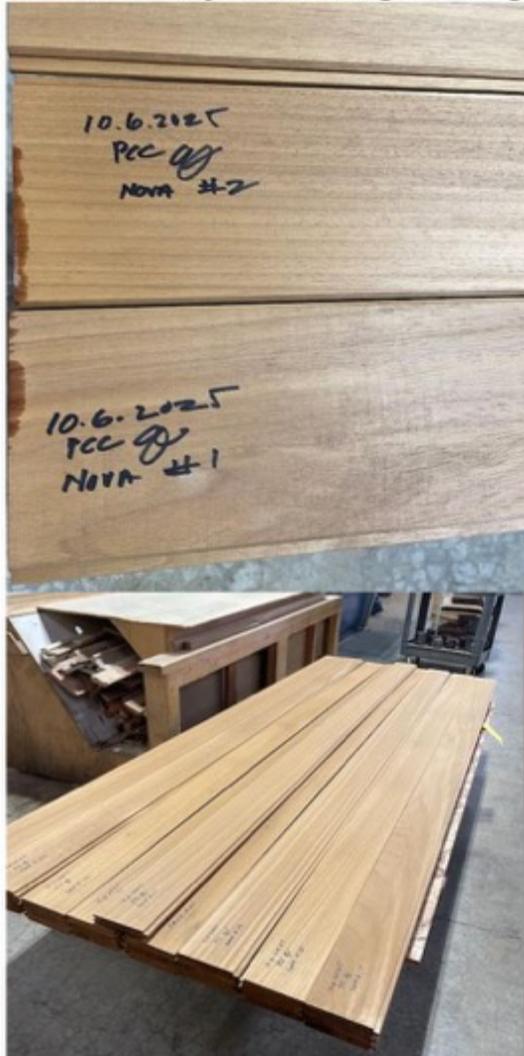
Photo 3 & 4—Inspection Markings on Siding

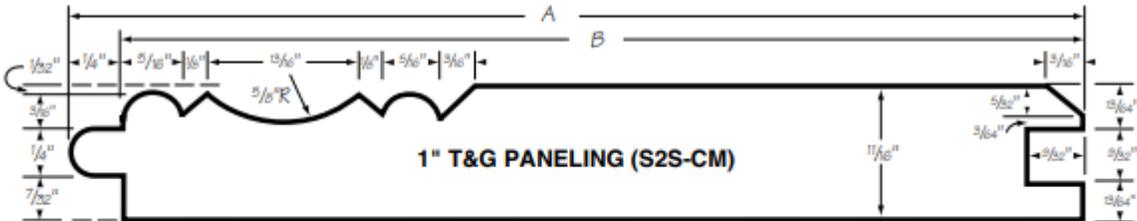
- Redwood Lumber Patterns No. 17
 - All nominal 1x6 and wider (not 1x4)
 - 16, 17, 18

NOMINAL SIZE	PATTERN NUMBER	A	B	CONVERSION FACTOR
1x6	16	5 3/8"	5 1/8"	1.18
1x8	17	7 1/8"	6 7/8"	1.17
1x10	18	9 1/8"	8 7/8"	1.13

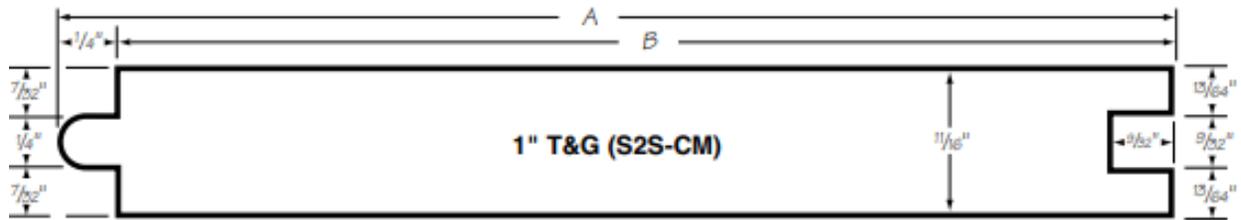
- 633, 634, 633EE, 634EE
 - EE = Eased Edge (Rounded)

NOMINAL SIZE	PATTERN NUMBER	A	B	CONVERSION FACTOR
1x4	632	3 ³ / ₈	3 ¹ / ₈	1.28
1x6	633	5 ³ / ₈	5 ¹ / ₈	1.18
1x8	634	7 ¹ / ₈	6 ⁷ / ₈	1.17

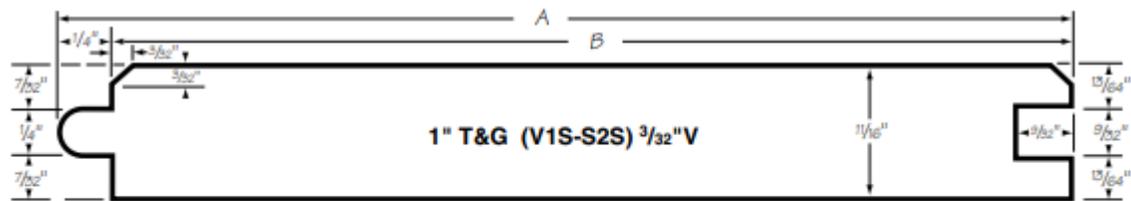
- 708, 715, 716, 708R, 715R, 716R

- R = Reversible

NOMINAL SIZE	PATTERN NUMBER	A	B	CONVERSION FACTOR
1x4	707	3 ³ / ₈	3 ¹ / ₈	1.28
1x6	708	5 ³ / ₈	5 ¹ / ₈	1.18
1x8	715	7 ¹ / ₈	6 ⁷ / ₈	1.17
1x10	716	9 ¹ / ₈	8 ⁷ / ₈	1.13

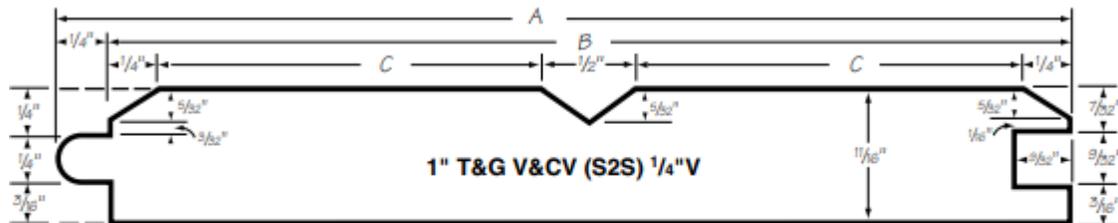
- 616, 617

NOMINAL SIZE	PATTERN NUMBER	A	B	C	CONVERSION FACTOR
1x6	616	5 ³ / ₈	5 ¹ / ₈	2 ¹ / ₁₆	1.17
1x8	617	7 ¹ / ₈	6 ⁷ / ₈	2 ⁵ / ₁₆	1.16
